Kansas City Southern Railway Conductor Fatality

Tupelo, Mississippi
December 23, 2020

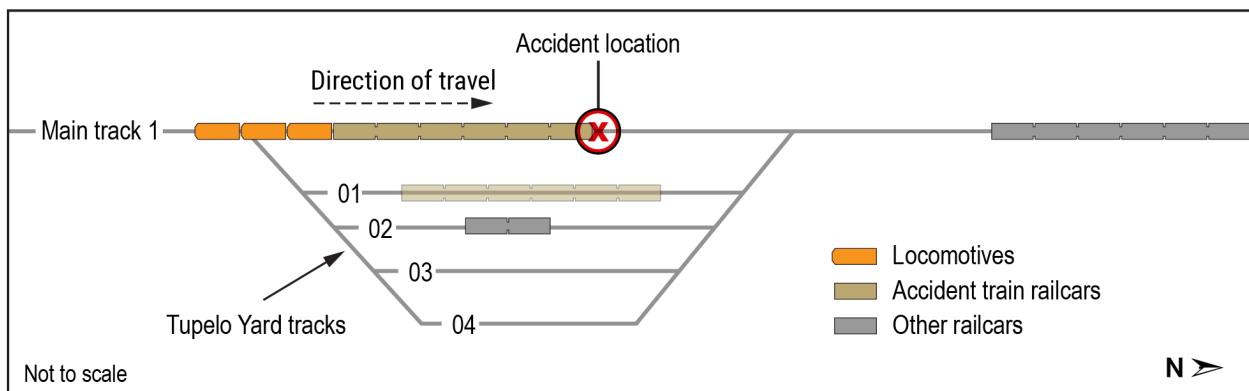
Figure 1. Diagram of accident location.

On December 23, 2020, about 6:55 a.m. local time, the conductor of Kansas City Southern Railway Company (KCS) train L-CO302-22 was struck and fatally injured by the train in the Tupelo Rail Yard in Tupelo, Mississippi.¹ The accident occurred on main track 1 at milepost 278.0 on KCS’s Artesia Subdivision. (See figure 1.) At the time of the accident, the train consisted of 3 locomotives and 22 railcars. It was dawn, the sky was clear, and the temperature was 44°F with light winds from the south.

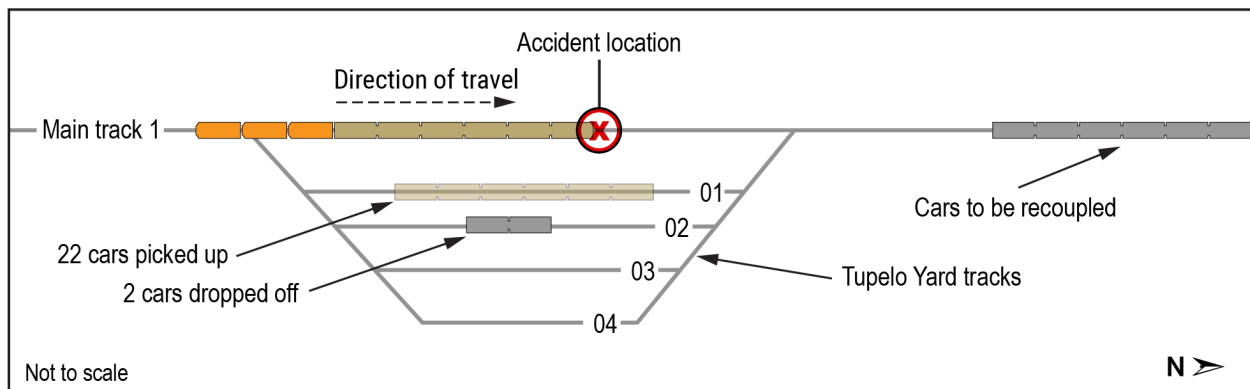
Figure 2. Diagram of accident location and switching operation.

After arriving at the north end of Tupelo Rail Yard, the crew uncoupled and secured railcars 3 through 46 on main track 1, leaving two railcars connected to the locomotives. The crew then proceeded to the south end of Tupelo Rail Yard where they uncoupled and secured the remaining two railcars on yard track 2. The crew then picked up 22 railcars from yard track 1 and returned to main track 1 to recouple with the cars left on main track 1. The accident occurred on main track 1. (See figure 2.)

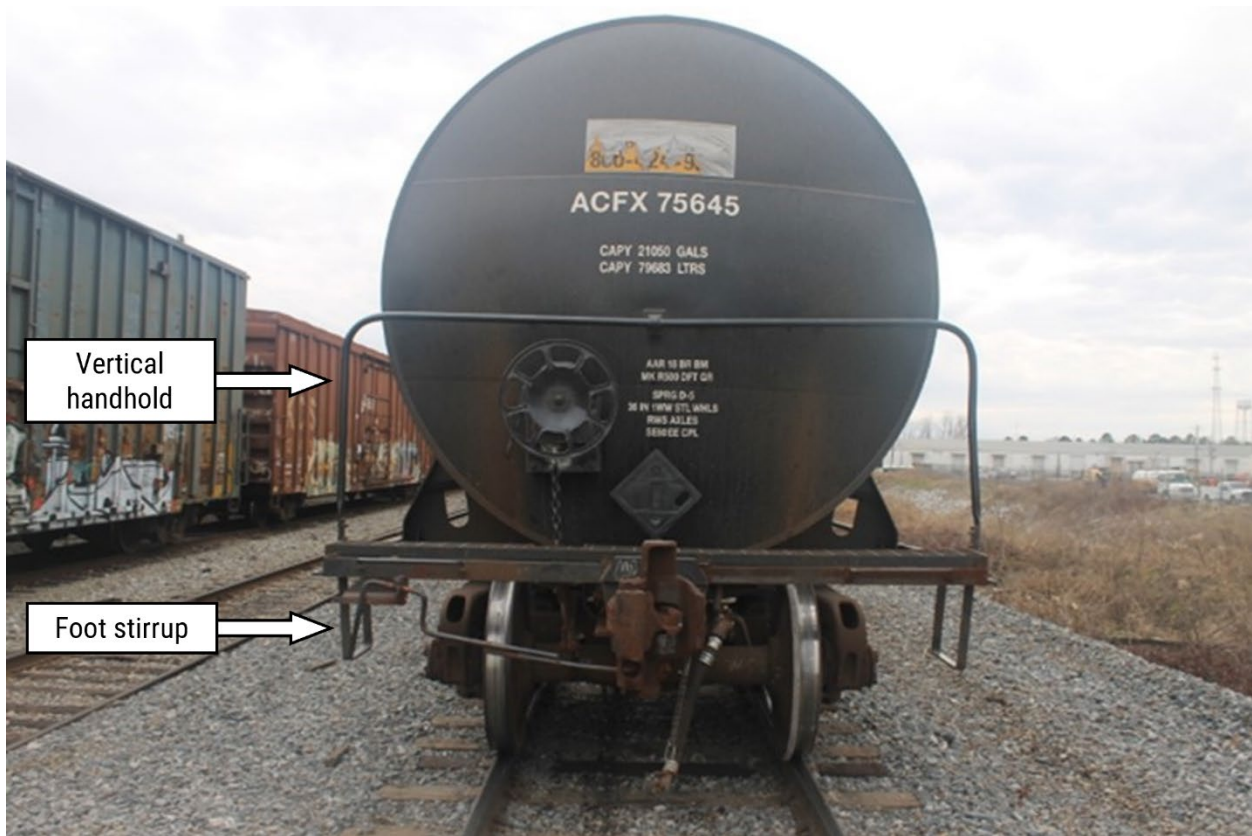
Figure 3. The end of the railcar where the conductor was riding.

The railcar that the conductor was riding was a DOT-111 tank car. The railcar was equipped with a foot stirrup and vertical handhold at each corner. (See figure 3.)

NTSB investigators could not determine the conductor's stance while riding the northeast corner of the railcar, including how he was using the handrail and stirrup and whether he was maintaining three points of contact.⁸ None of the KCS employees interviewed during the investigation witnessed the accident, and the train's forward- and rear-facing locomotive image recorders did not have a view of the conductor.

The conductor was likely holding on to a vertical handhold while operating a handheld radio and may have been in an unstable position while preparing to make the coupling. If slack action occurred unexpectedly, the conductor could have fallen into the path of the moving train.
